CRV Plate helps protect servo-valve components against varnish

By Cary Forgeron, CLS, Analysts Inc

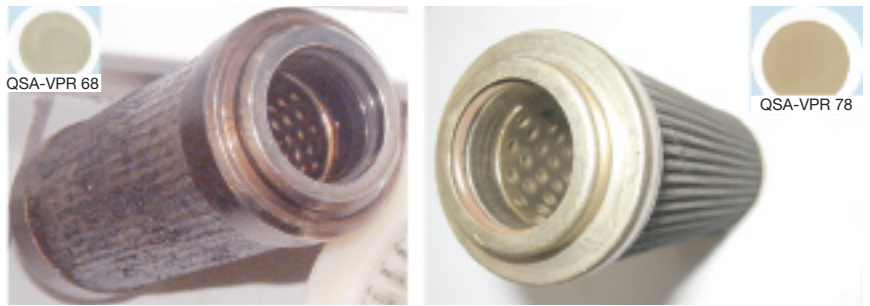
2, 3. The positive impact the CRV Plate has on varnish mitigation is easy to see by comparing the two photos of the filter for a fuel splitter valve. At the left, note the extensive fouling prior to installation of the CRV Plate. Replacement filter at right has 3000 hours of operation on the same oil after the CRV Plate was installed

Proof of the CRV Plate's value is illustrated in Figs 2 and 3, which show the last-chance filter for a gas splitter valve on a Frame 6 turbine. In Fig 2, varnish covers the filter inside and out. The operating time on the oil is approximately 4000 hours and QSA testing confirmed a VPR of 68 (an alert level).

The valve and filter were replaced and a CRV Plate was installed, but the LO was not changed-out. Fig 3 shows the filter after approximately 3000 hours of operation. Note that there is no agglomeration of varnish on the

filter media, despite QSA results indicating an increase in the oil's VPR. Since installation of the CRV Plate, there have been no operating issues related to varnish formation in the corresponding servo valve.
